**Cardinal[®] IG**

with **XEDGE[™]**

A New Direction,
With Reduced Risk.

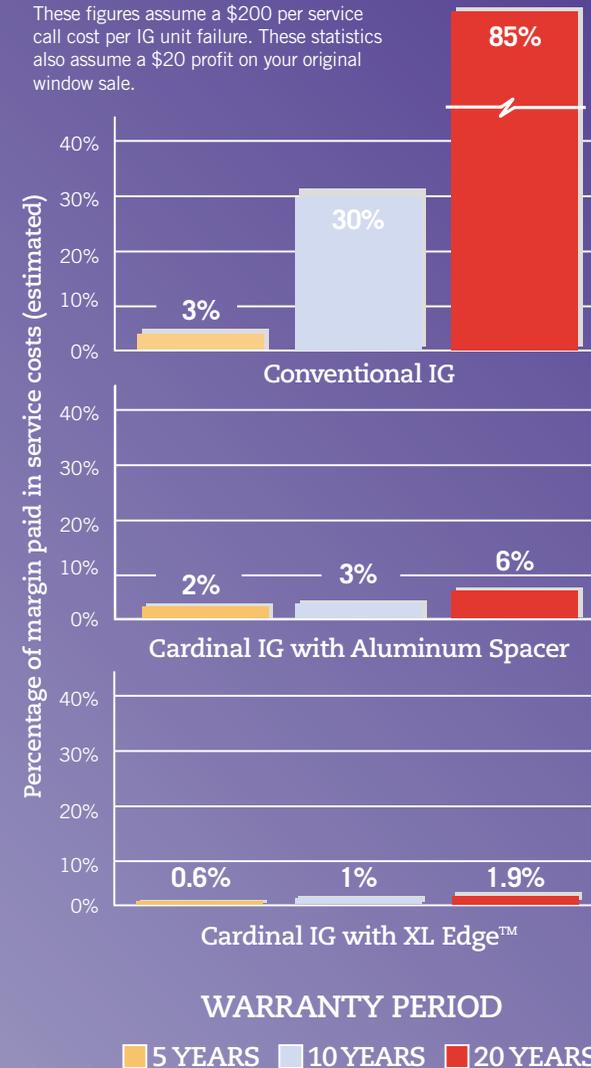
These graphs estimate the cumulative percentage of your profit margin from window sales that can be lost to service costs. Over time, conventional IG units are increasingly prone to failure. The longer the warranty period, the more your profits may be eroded by service costs.

These figures assume a \$200 per service call cost per IG unit failure. These statistics also assume a \$20 profit on your original window sale.

The accompanying graphs approximate the service costs associated with making your own insulating glass versus buying Cardinal IG units with an aluminum spacer or Cardinal IG with XL Edge. These statistics show the cumulative percentage of the original profit margin on your window sales that could be lost to service costs over time.

Contrast that with XL Edge. As these graphs underscore, the fewer IG failures, the greater percentage of profits you can keep.

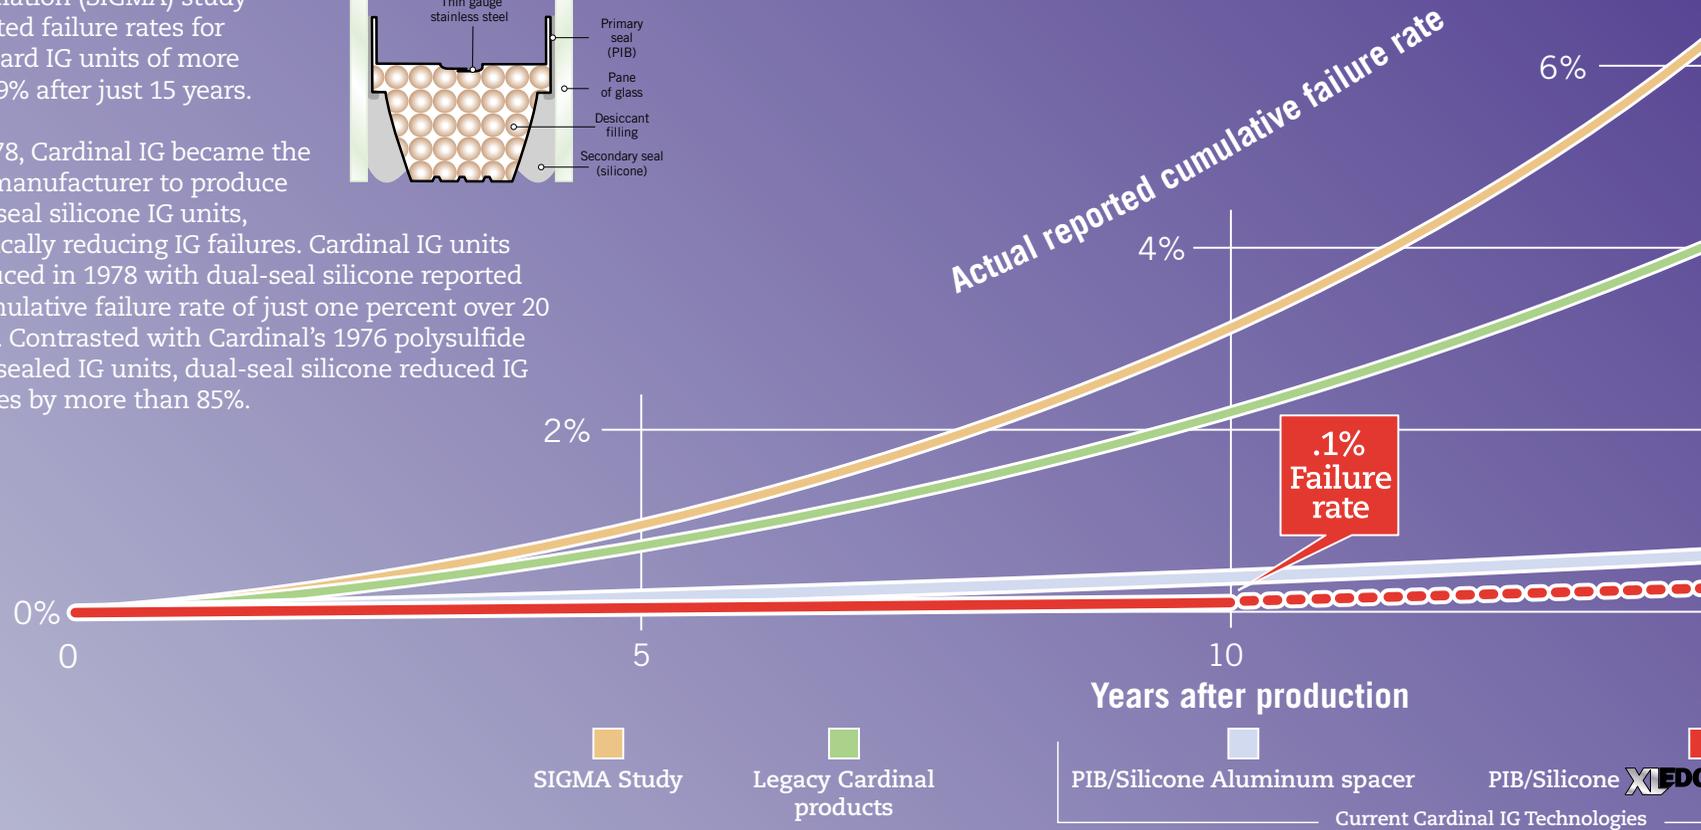
If IG failures are cutting into your company's or channel partner's margins, Cardinal understands. Cardinal IG has used dual-seal polysulfide seals in its units for years. As this chart indicates, Cardinal units produced in 1976 showed a failure rate of 8.5% after 20 years. That's on par with industry statistics: a Sealed Insulating Glass Manufacturing Association (SIGMA) study reported failure rates for standard IG units of more than 9% after just 15 years.

In 1978, Cardinal IG became the first manufacturer to produce dual-seal silicone IG units, drastically reducing IG failures. Cardinal IG units produced in 1978 with dual-seal silicone reported a cumulative failure rate of just one percent over 20 years. Contrasted with Cardinal's 1976 polysulfide dual-sealed IG units, dual-seal silicone reduced IG failures by more than 85%.

In 1993, we introduced XL Edge, a revolutionary IG unit combining a dual-seal silicone system with patented stainless steel – rather than aluminum – spacers. XL Edge is the most durable IG unit available today. Based on a decade's worth of experience, we project that the failure rate for Cardinal IG with XL Edge over 20 years will be well below 0.5 percent. Where are you sitting on the failure rate chart?

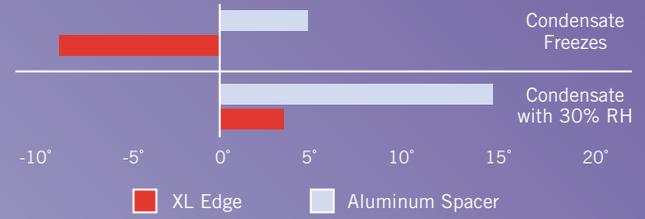
Outdoor temperature (°F) when condensation event occurs

In all windows, condensation can appear around the perimeter of the glass, making the window aesthetically unappealing and potentially damaging the sash and frame components over time. The warm-edge characteristics of XL Edge reduce the frequency and amount of condensation during the most extreme temperature conditions. The chart below shows that for a typical wood/vinyl window design, it would have to be 12°F colder outside before condensation forms on a unit with XL Edge.
